HARFORD COUNTY DPW

UPPER FARNANDIS SMALL WATERSHED ASSESSMENT REPORT

APRIL 02, 2018

HARFORD COUNTY DEPARTMENT OF
PUBLIC WORKS

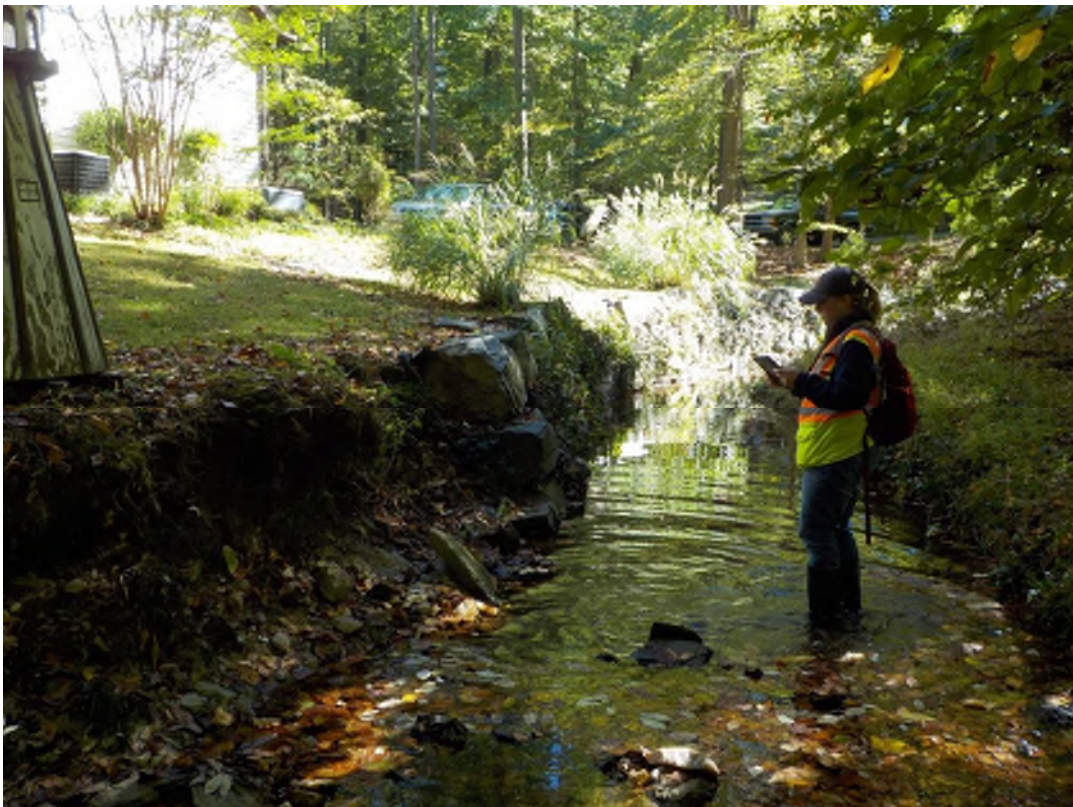
Figure 14: Inadequate buffer along mainstem. Lawn comes directly to right bank of stream. Inadequate buffer along right bank for majority of mainstem reach between culvert under Carolina Avenue to confluence with tributary 3.

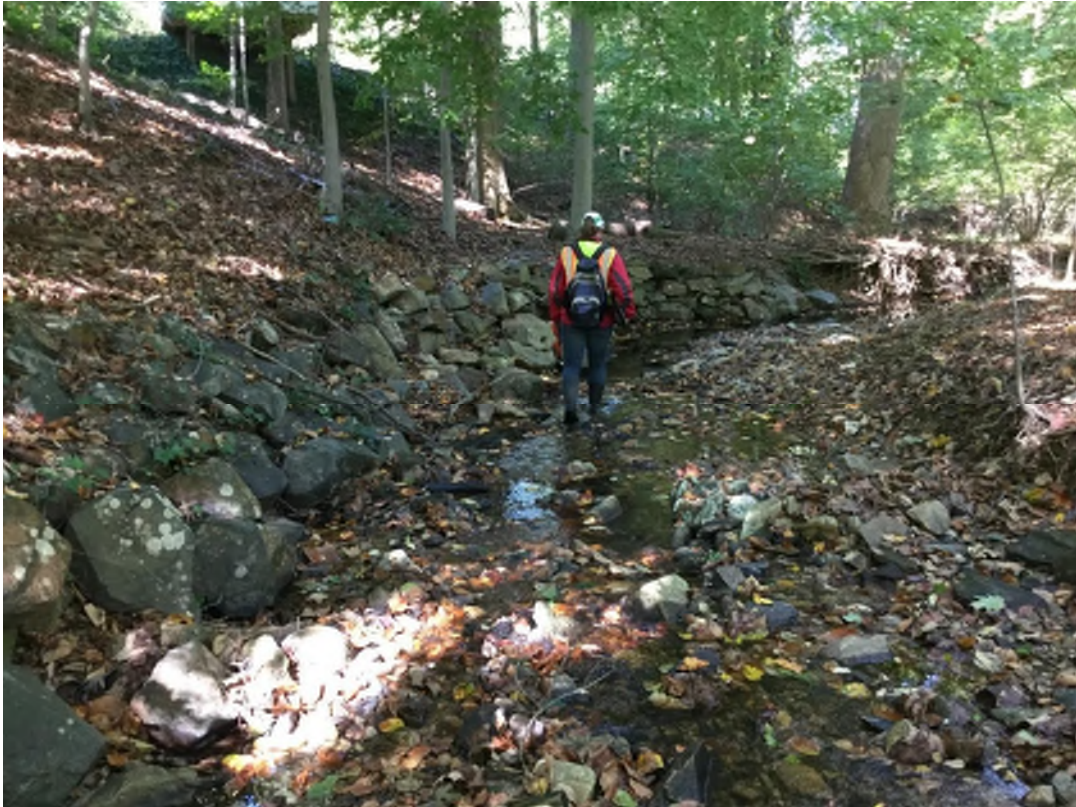
Figure 15: Channel alteration in mainstem. Left bank armored with stone boulders for approximately 33 feet.

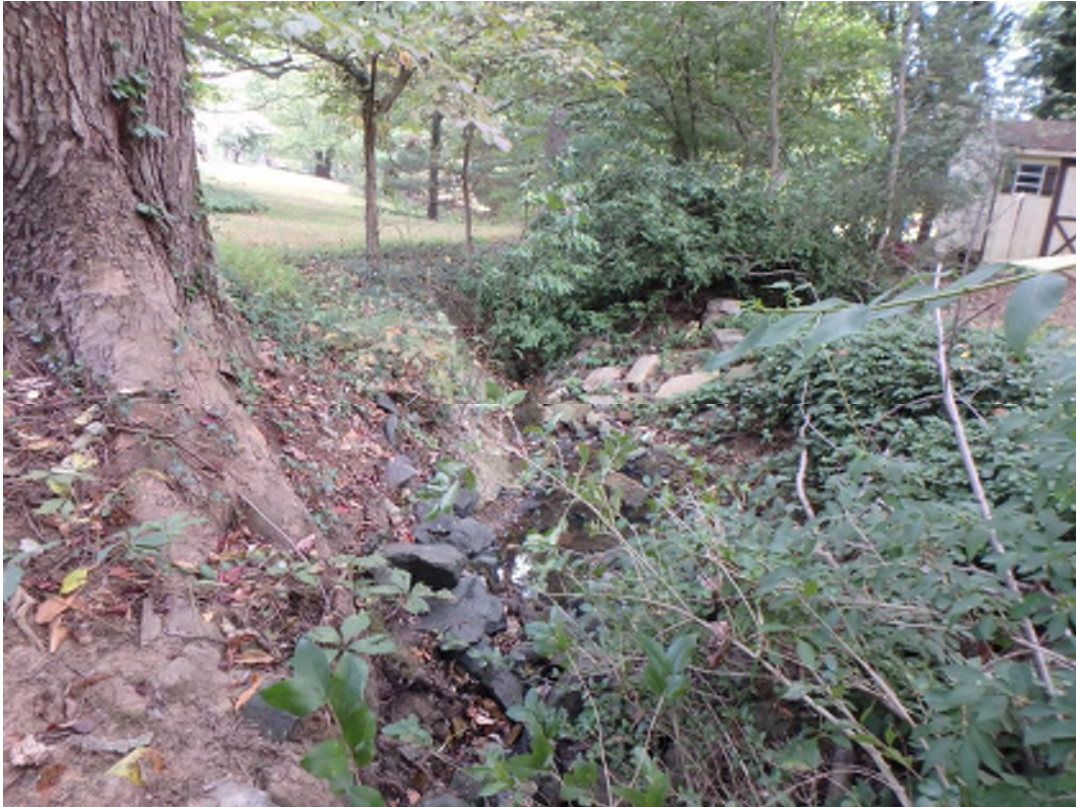
Figure 3: Lawn to edge of stream banks. Inadequate buffer present in mainstem.

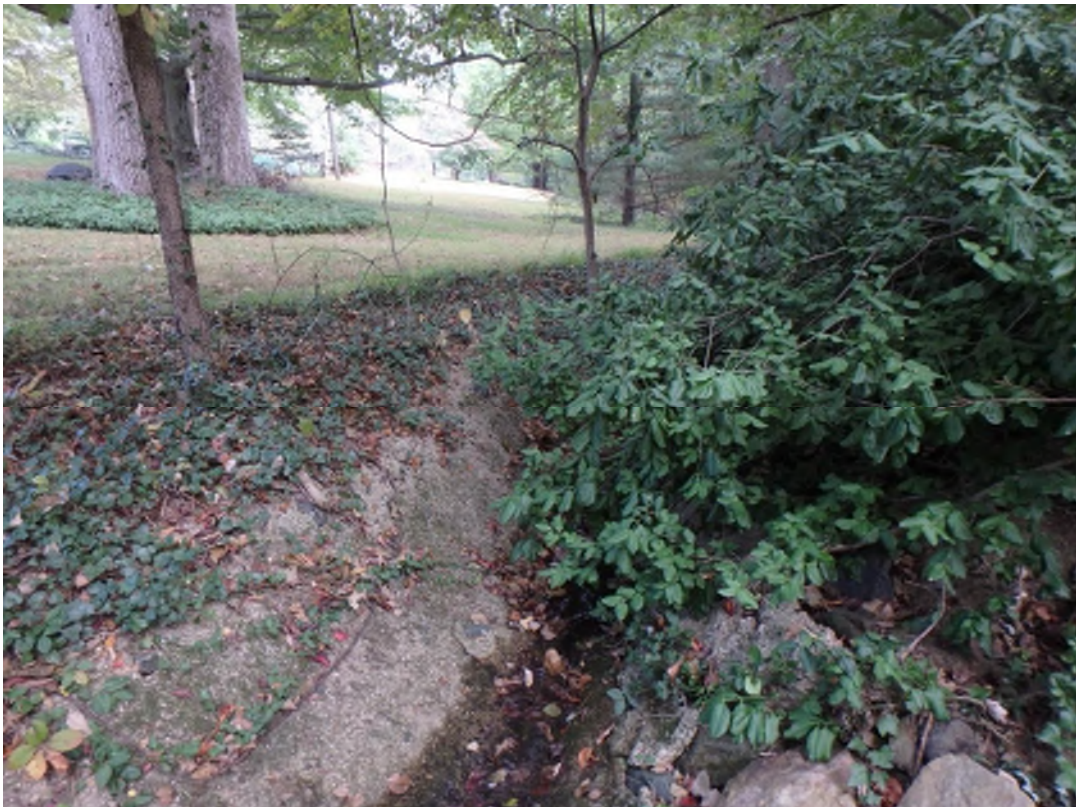
Figure 4: Concrete armored banks in mainstem for approximately 233 feet.

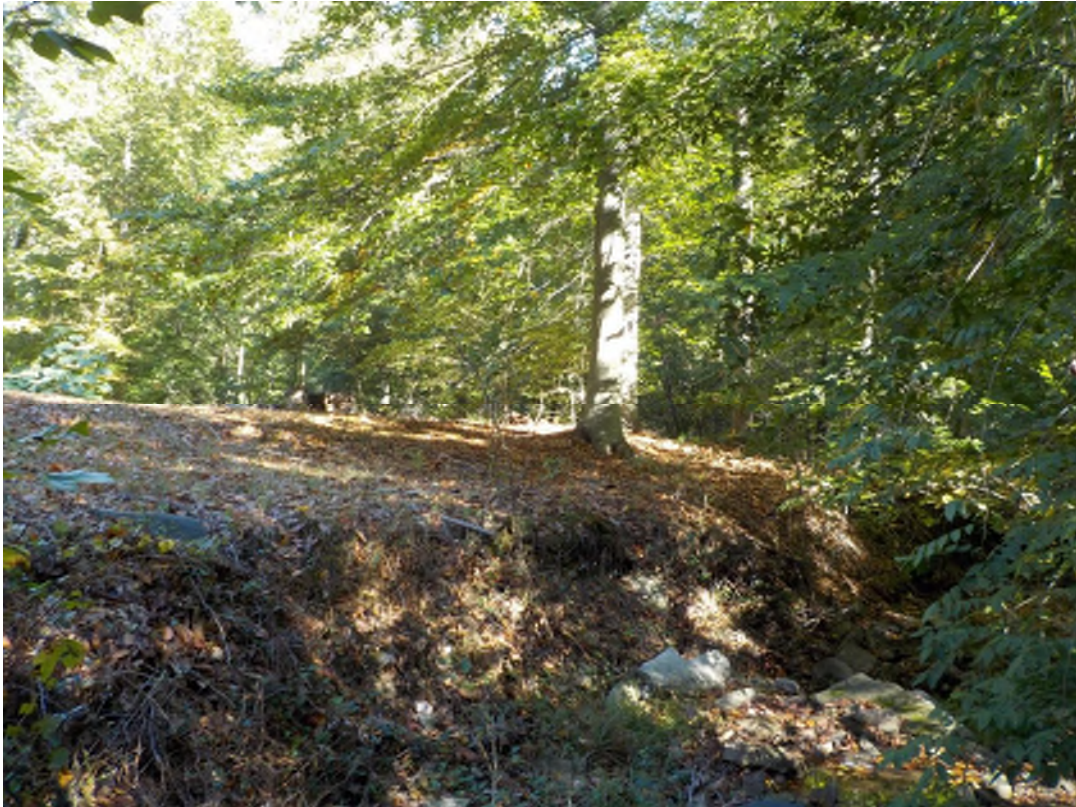
Figure 17: Inadequate buffer along mainstem. Lawn comes to edge of bank.

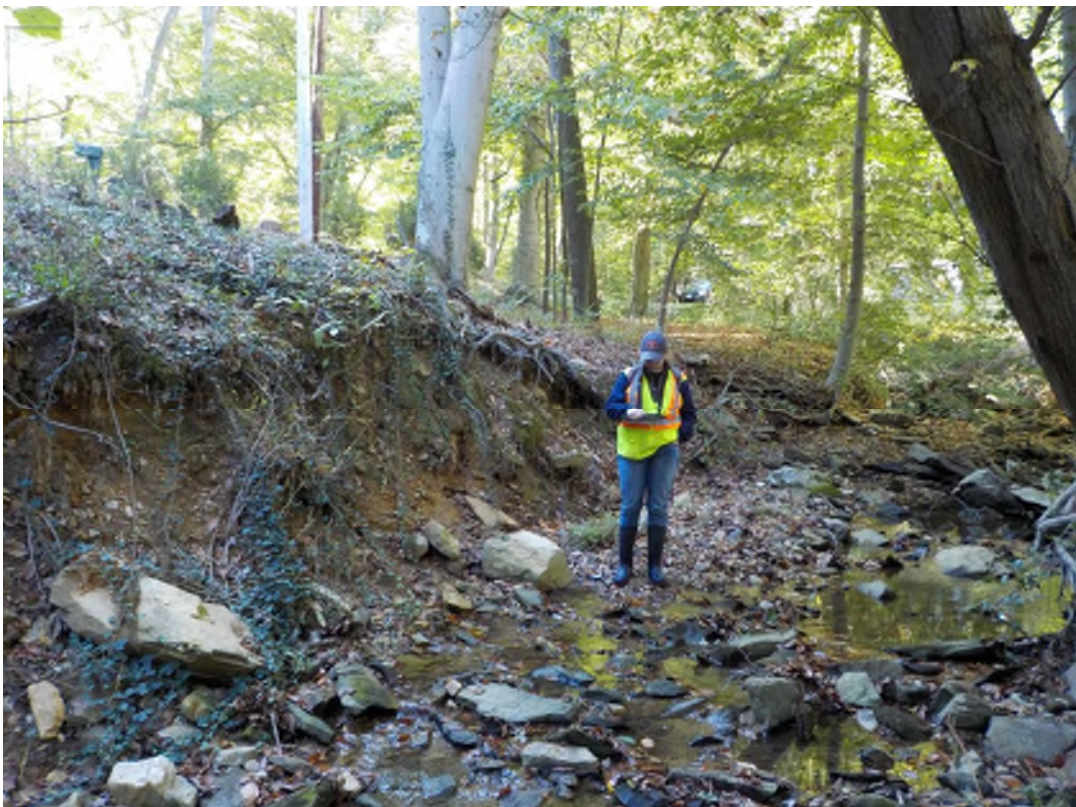
Figure 18: Bank erosion on mainstem.

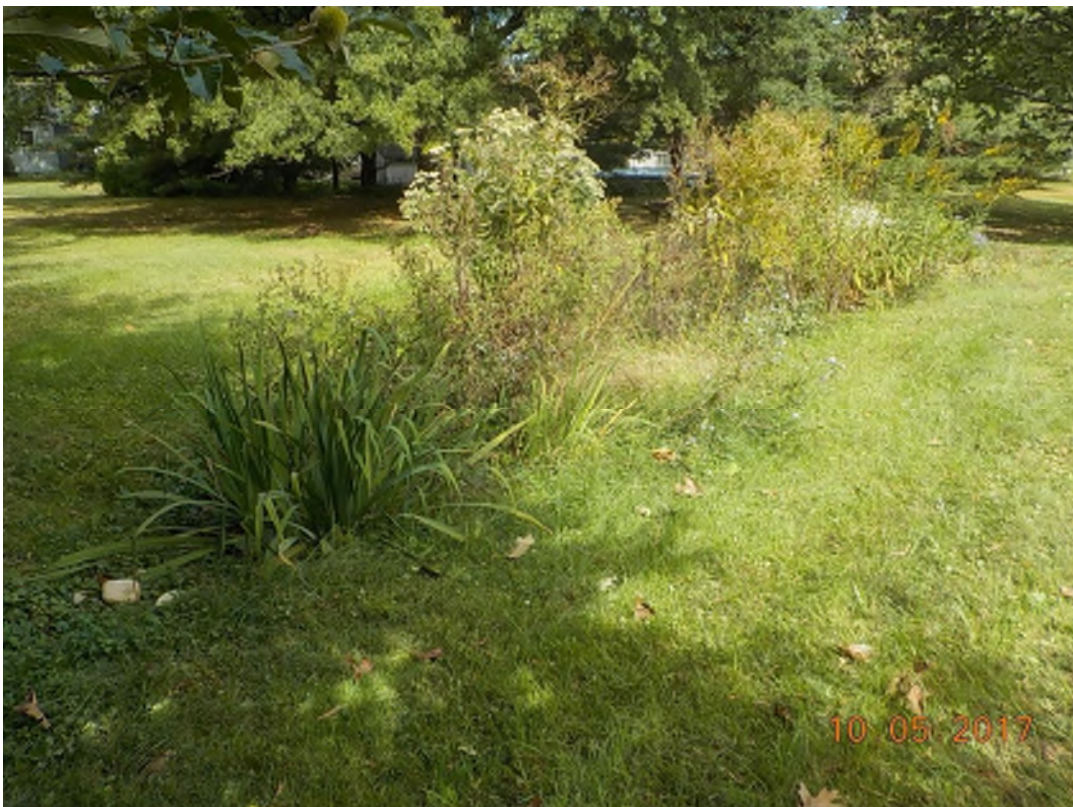
Figure 22: Existing BMP 5 is a rain garden at Christ Our King United Presbyterian Church on Lexington Road. Flow is conveyed to facility via riprap channel. Overflow to follow existing drainage network. Retrofit not recommended.

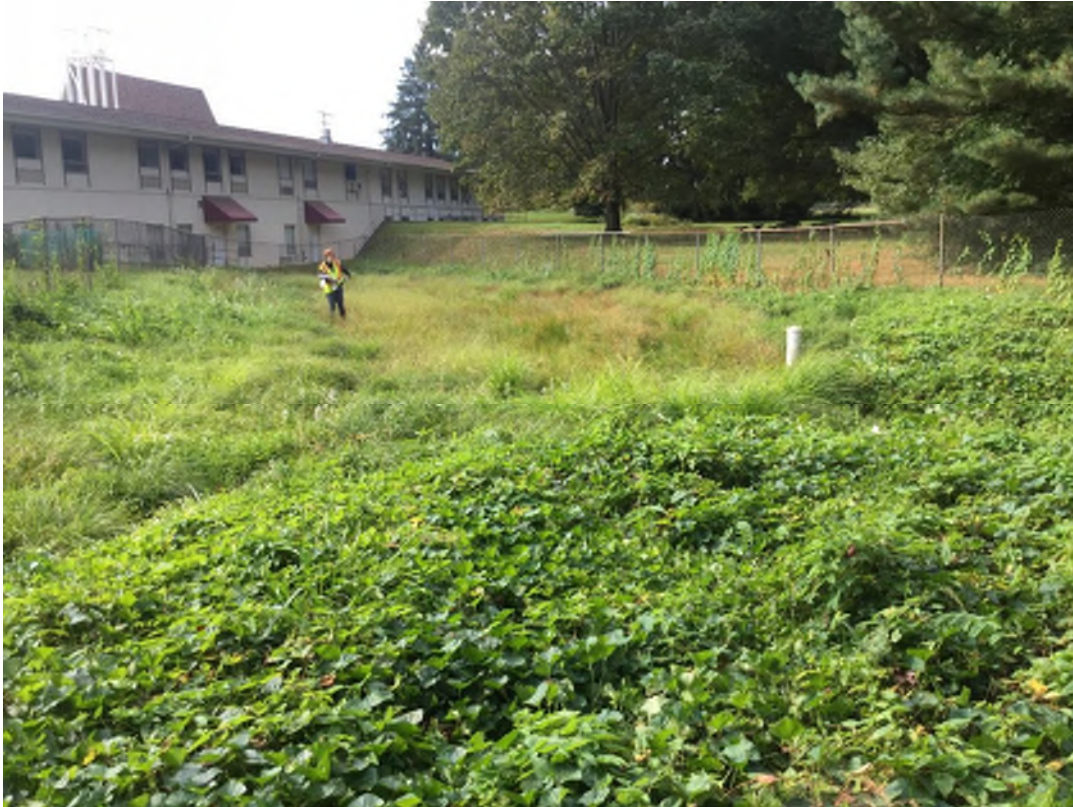
Figure 23: Existing BMP 6 is an infiltration trench located at Christ Our King United Presbyterian Church on Lexington Road. Flow is conveyed to the facility via downspout disconnection. Outfall to existing drainage network. Retrofit not recommended.

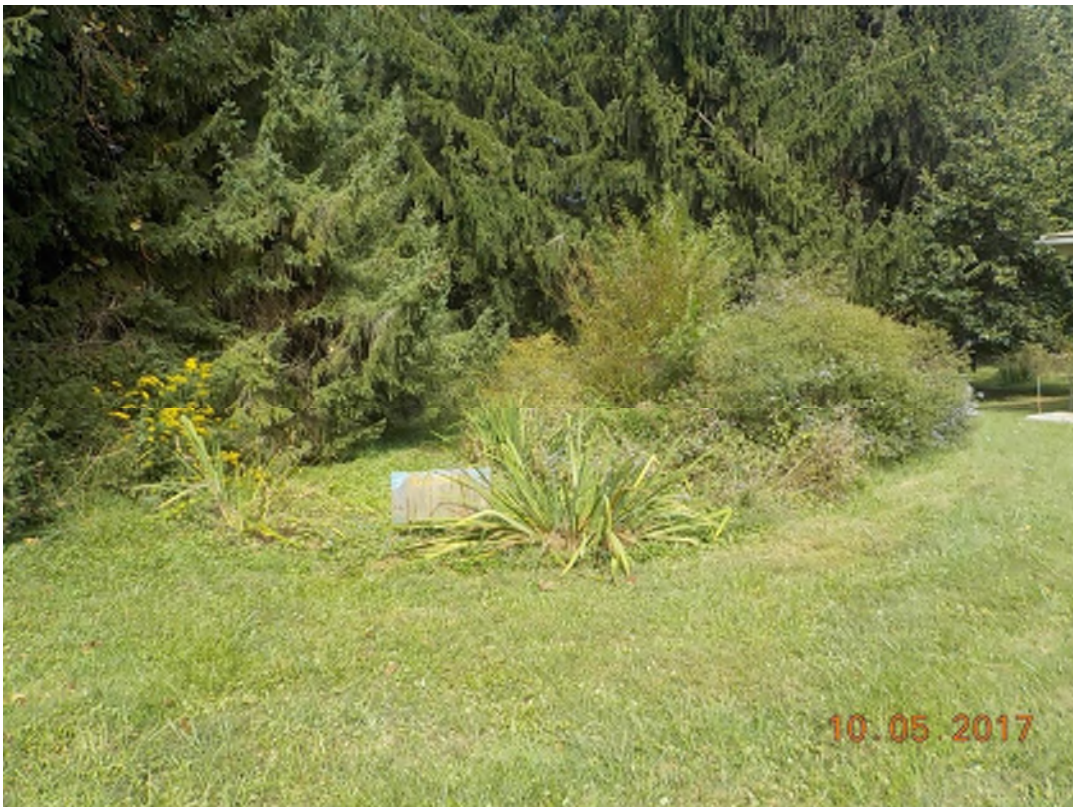
Figure 24: Existing BMP 8 is a rain garden at Christ Our King United Presbyterian Church on Lexington Road. Flow is conveyed to the facility via overland flow from downspout disconnection. This facility is not recommended for a retrofit.

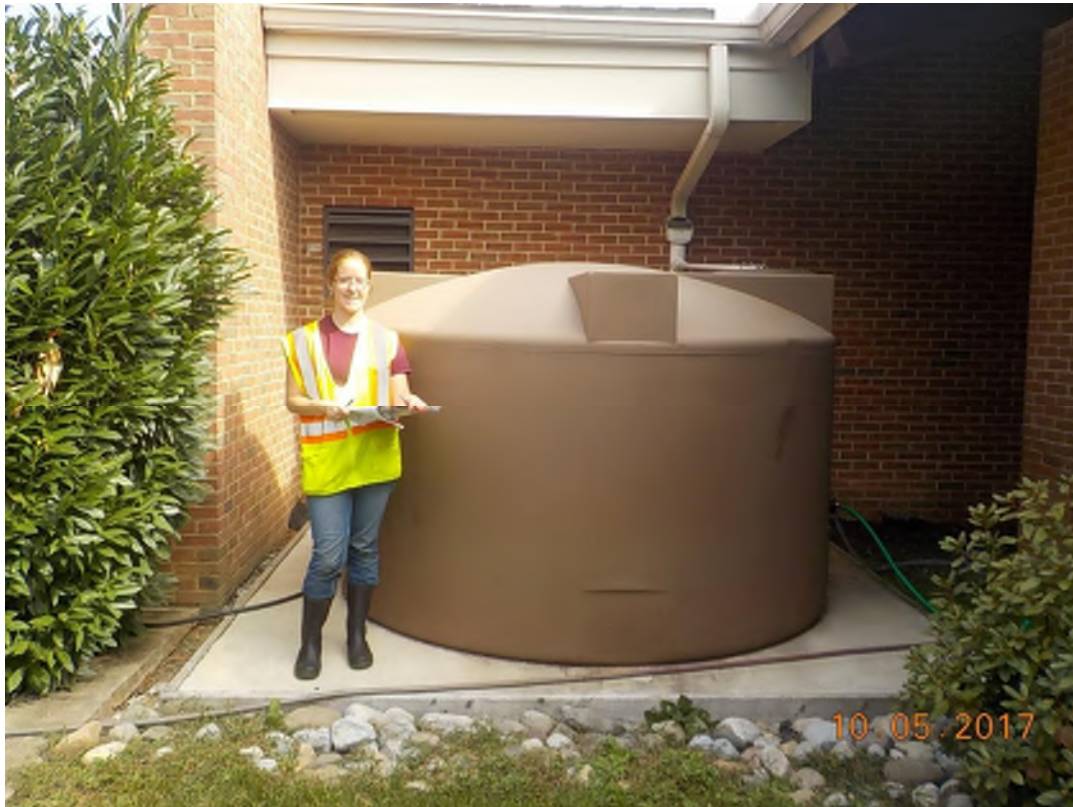
Figure 25: Existing BMP 9 is a rain barrel at Christ Our King United Presbyterian Church on Lexington Road. Flow is conveyed to the facility via downspout disconnection. Flow exits facility via PVC pipe. This facility is not recommended for a retrofit.

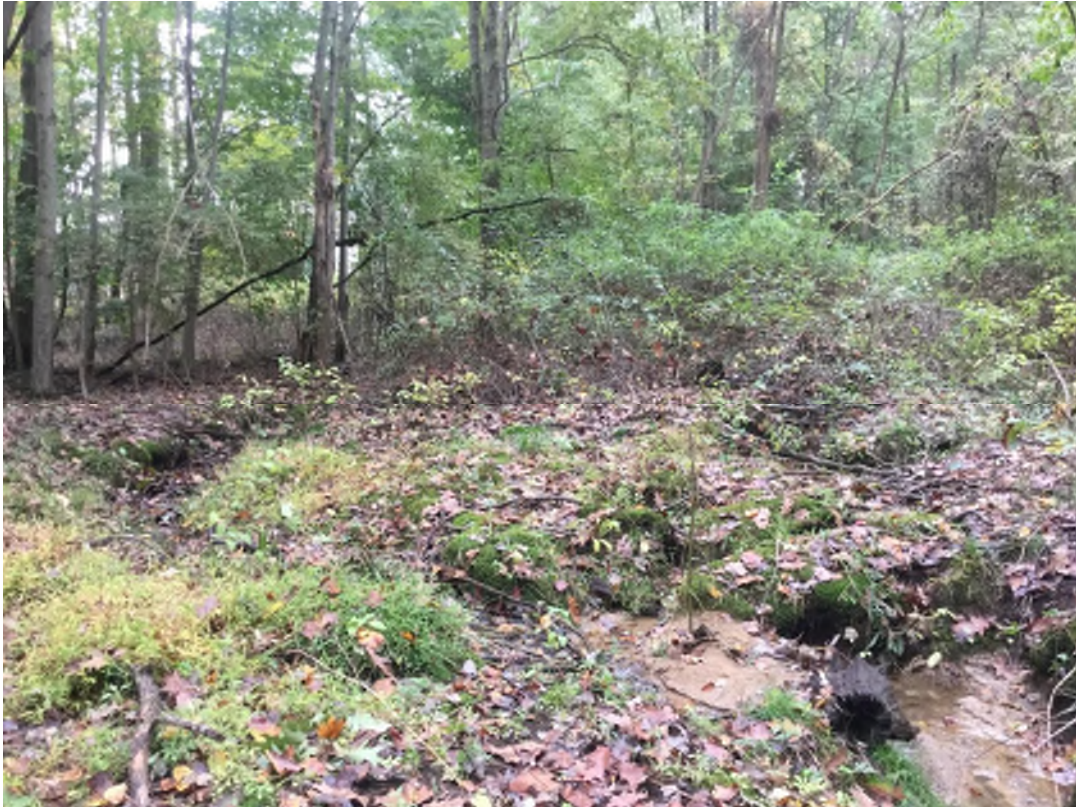
Figure 7: Sediment deposition and shallow channel causes braiding in tributary 1. Channel shifted to left of original channel.

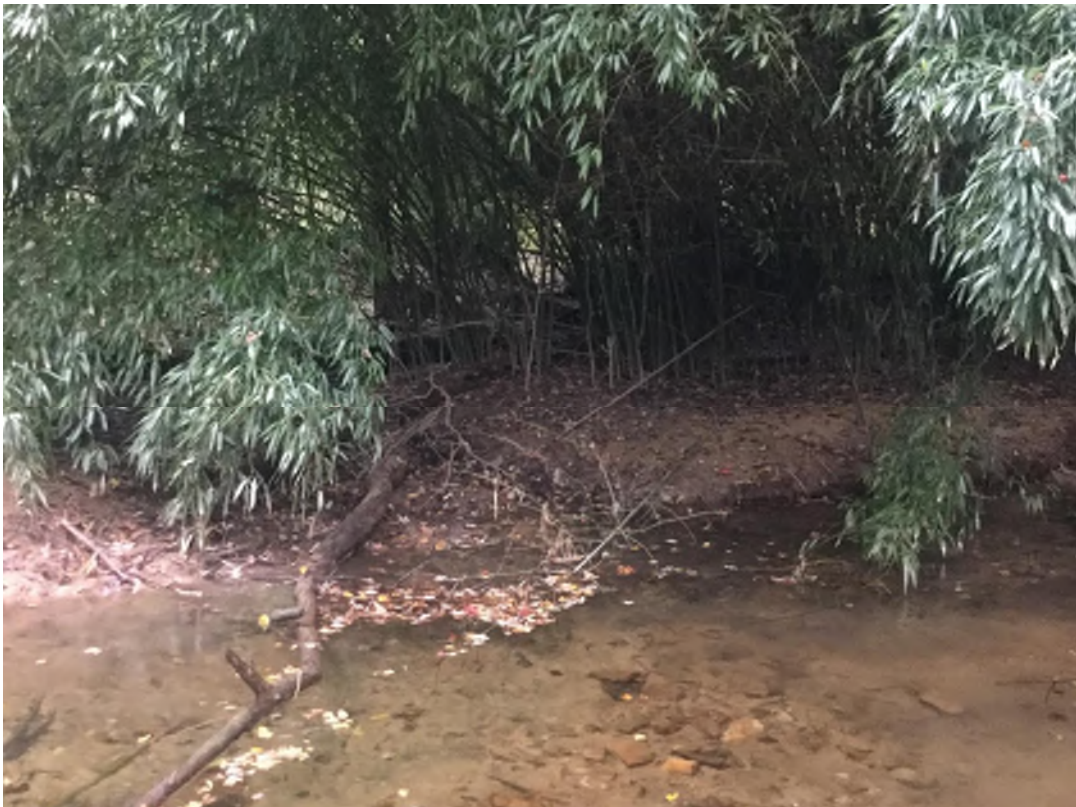
Figure 8: Tributary 1 confluence with mainstem. Tributary 1 enters mainstem on right bank. Minimal flows entering mainstem from tributary 1.

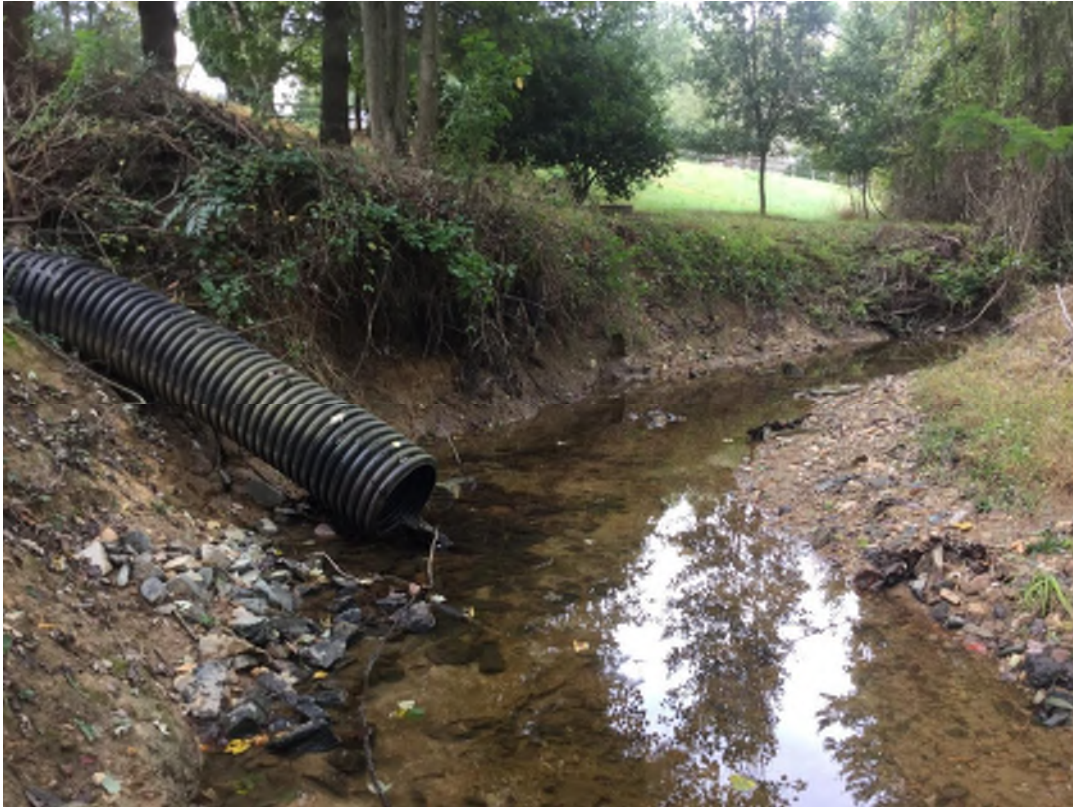
Figure 17: Outfall 31 is an 18-inch plastic pipe conveying flow to the right bank of the mainstem. Outfalls directly into stream. Outfall structure has severe damage.

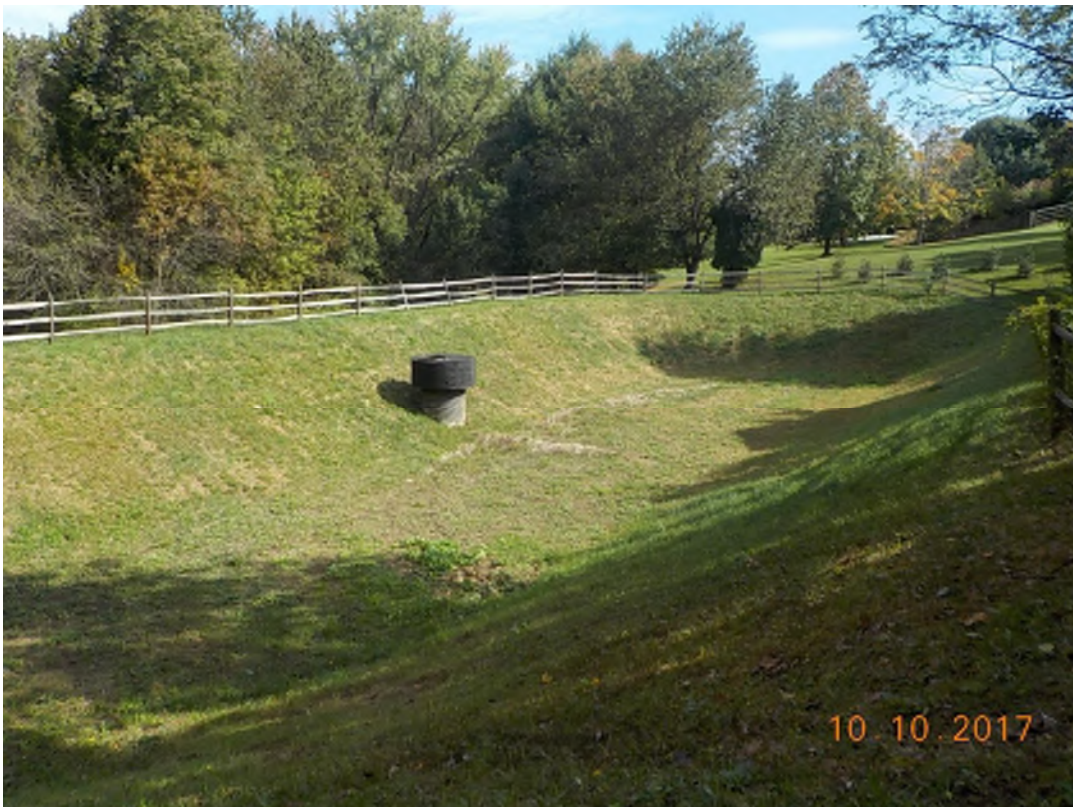
Figure 18: Existing BMP 2 is an extended detention basin in Brook Hill Court. Inflow from the surrounding neighborhood via two pipes. Outfall via metal riser to gabion outfall protection. Proposed wet pond retrofit.
